Generation of Mechanical Frequency Related Harmonics in the Stray Flux Spectra of Induction Motors Suffering from Rotor Electrical Faults

Gyftakis, K, Panagiotou, P & Lee, SB 2020, 'Generation of Mechanical Frequency Related Harmonics in the Stray Flux Spectra of Induction Motors Suffering from Rotor Electrical Faults', *IEEE Transactions on Industry Applications*, vol. 56, no. 5, pp. 4796 - 4803. <https://doi.org/10.1109/TIA.2020.3002975>

IEEE Transactions on Industry Applications

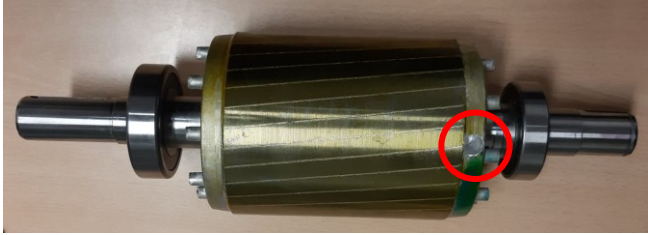
Fig. 10. The rotor with one broken rotor bar.
